How Do Concrete Remedy Deep Seal and Top Seal Work?

These pictures are of testing done with Deep Seal and Top Seal. The left section of the slab is bare, the middle section was treated with DS. The right section was treated with DS which was allowed to dry one day, then the area dampened with water. The TS was applied on a dampened surface which was still dark gray.

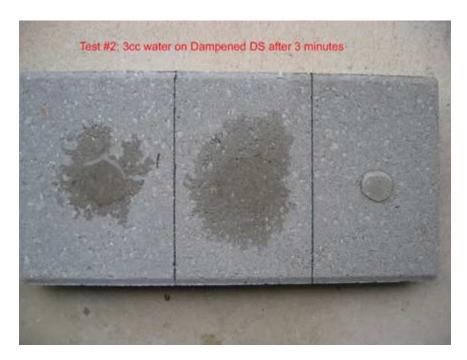
Below, the middle section after 3 minutes covers more than twice the area of the water on the left, bare section

You will notice that over time, the water darkened area in the middle section grows larger than the left spot. The illustrates that on the bare concrete the water tends to soak straight down into the concrete, while in the middle section, the presence of the DS beginning about 1-2 mm below the surface prevents that kind of absorption. Instead, in the middle section the water can only go down about 1-2 mm and then it starts spreading out horizontally...increasing the size of the moisture darkened area.

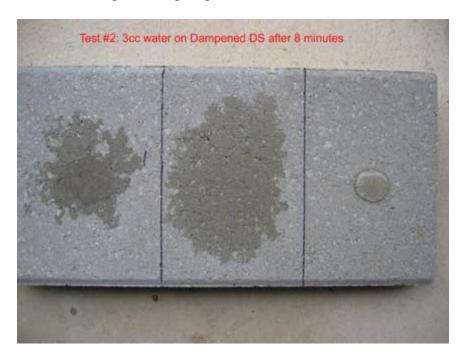
After 8 minutes, the center section has continued to grow as the water spreads out horizontally because the Deep Seal is blocking it from going down into the slab.

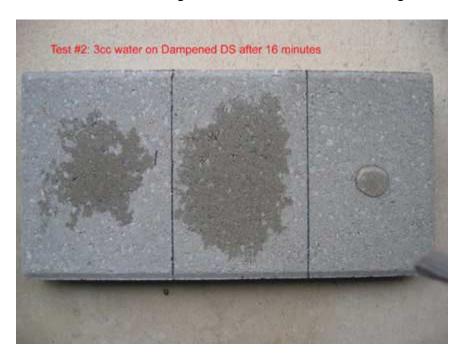
While hard to see at this resolution, there is still slight moisture on the surface in the two left sections, bare and DS only... the beaded 3 cc.s on right on the DS/TS has not changed at all.

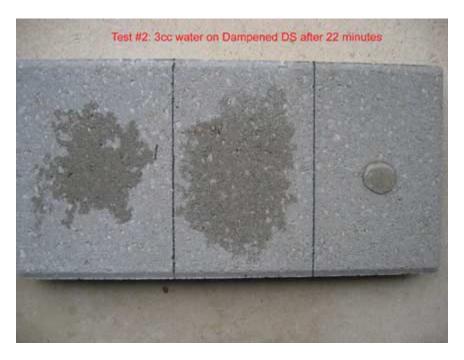
After 22 minutes you can notice that the middle section is starting to lighten up in color around the edges and at some places in the darkened (wet) area... the bare section on the left is not showing this lightening or drying.

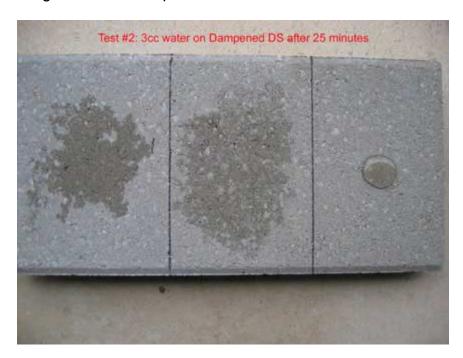
By 25 minutes the difference in drying between the left and middle sections is becoming more evident... with the DS treated area getting dry faster than the untreated section on the left, which is darker in color, indicating more moisture present.

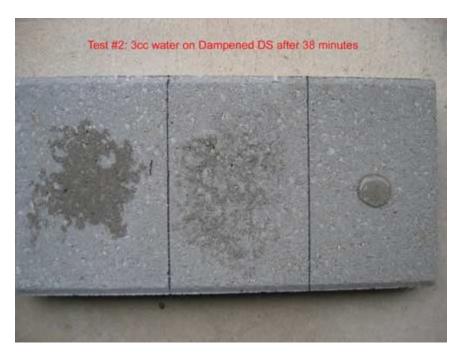
The pronounced drying of the center section becomes more evident at 38 minutes, compared to the left (untreated) section which is still quite dark, i.e., wet.

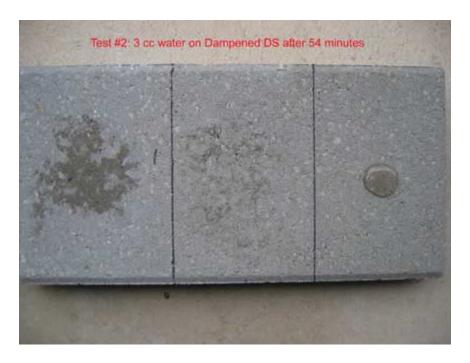
After just under an hour, the 3 ccs of water has almost completely dried where it was applied on top of the Deep Seal....while the 3 ccs applied on the left untreated section still shows dark indicated presence of water.

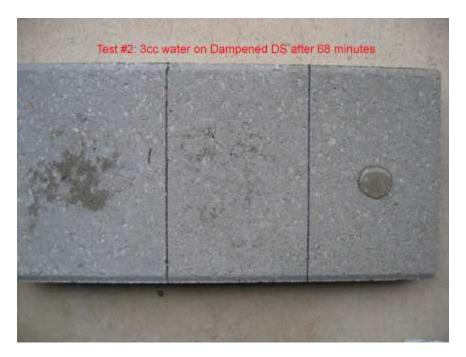
After a little over an hour, the middle DS treated section is pretty much dry, but water still evident on the left. The right Top Seal section shows the 3 cc's of water still beaded with none having soaked in. This graphically shows that concrete treated with DS does not stay damp or wet as untreated concrete. If it had rained on this slab, say 1/2 inch of rain or more, the slab on the left would have been totally saturated and full of water... appearing dark gray over the whole surface...while the DS treated section would appear as it does below... because the only water that could have soaked into the DS treated section would have been in the top 1-2 mm of the surface... which as you can see dries quickly. This test was done in southwest Missouri where humidity is relatively high, and no sun hit this slab during the test.

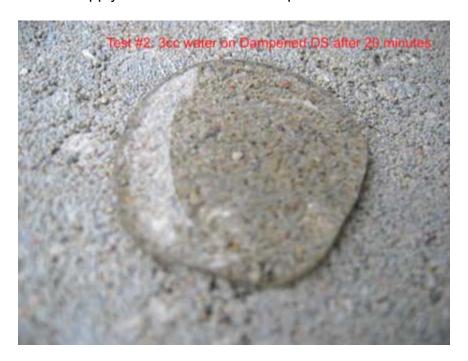
This is a closeup of the 3 cc's of water on the right hand side, which was treated with DS and then TS... after 20 minutes. The area about the size of a 50 cent piece stayed the same until it eventually evaporated more than 30 hours after application. Had that 3 ccs of water been broomed off, that area would have been dry in a few minutes. However, the beading effect does not last... it is not designed as a "beading" material. It will hold out moisture even though the surface tension does not create beading. The way Top Seal works is quite different from commonly seen sealers that advertise if it stops beading you have to reapply. That is NOT true of Top Seal because it works differently.
